# Home Inspection Report

**13579 Phaedra Lane, Redding CA**

**Riley Johnson, CCI**

**Shasta Home Inspections, LLC**  
**530-945-6292 [Shastainspections@gmail.com](mailto:Shastainspections@gmail.com)**

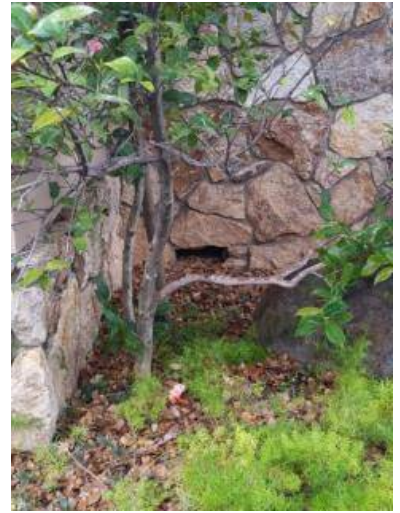
[CR] Several foundation vents at or below exterior grade level. This condition is conducive to moisture intrusion into the crawl space.

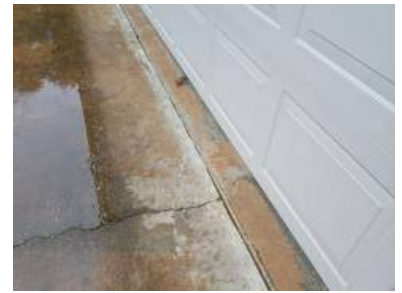
Note: Transition from driveway to garage floor is a potential trip hazard.

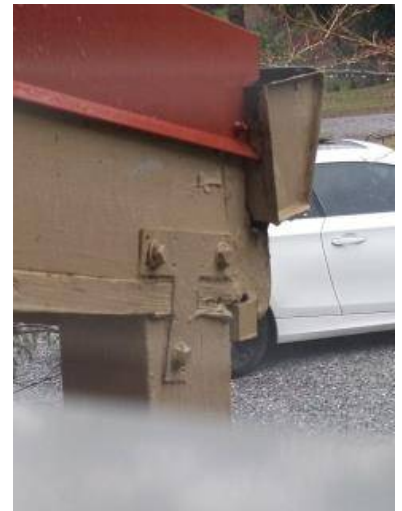
[FE] Damage/deterioration observed on the patio/deck cover framing.

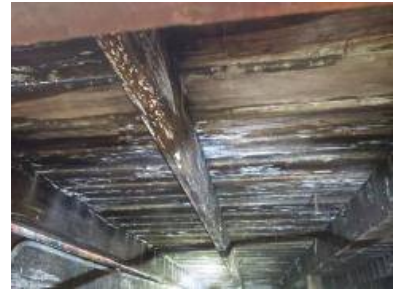
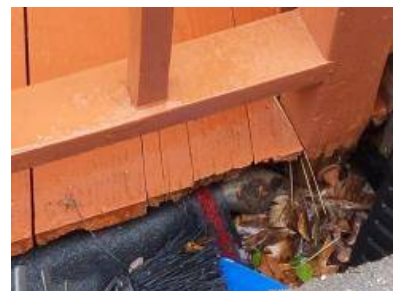
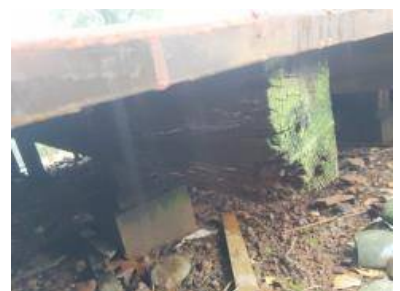
[FE] Numerous areas of damage observed at all deck platforms and framing. Surface fungus and moisture related damage observed throughout deck. All decking will require major repairs or replacement.

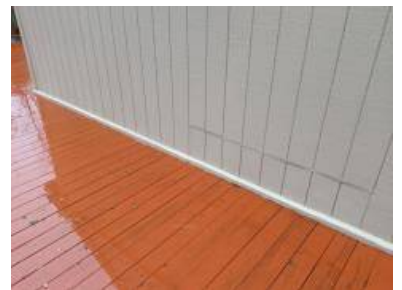
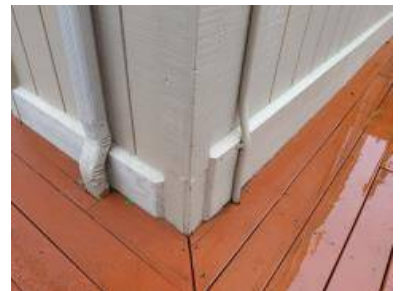
[CR] The deck lacks proper flashing where it meets the siding. Water may pond in this area and damage deck and siding.

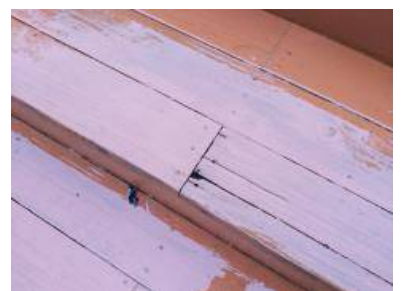
[CR] Moisture-related damage observed on the steps/stairs.

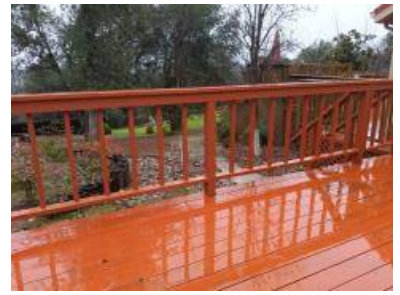
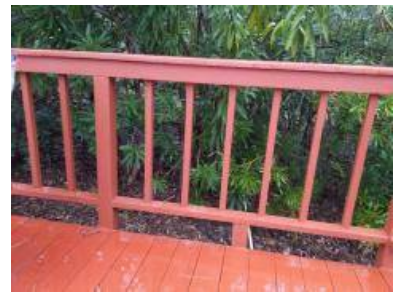
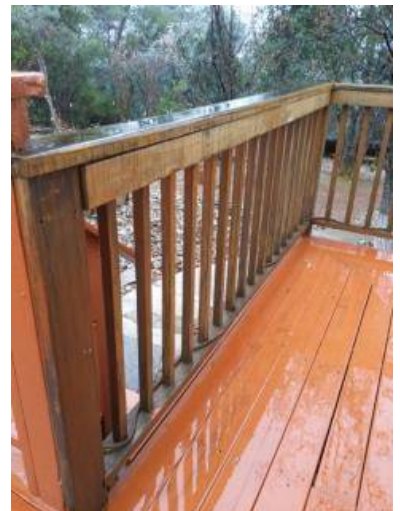
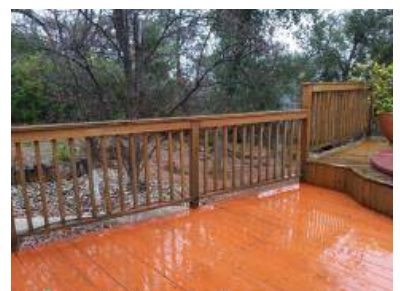
[SC] The guardrail balusters have spaces/gaps. Maximum allowable space between balusters is 4". This is a safety concern for small children and pets.

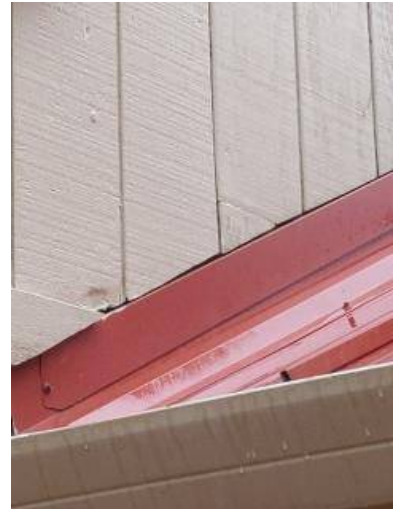
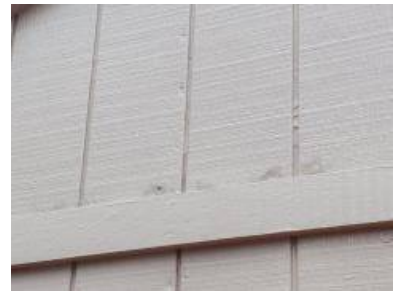
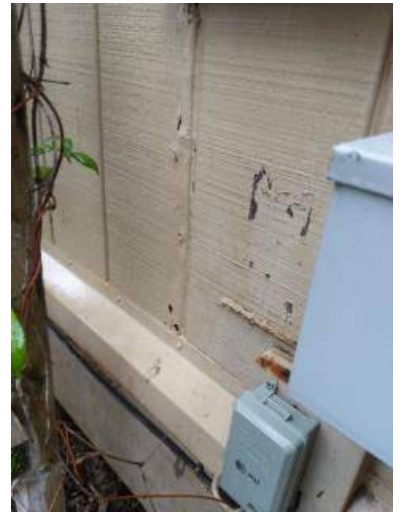
[FE] The wood siding has moisture damage/deterioration at localized areas of the building. These conditions are conducive to moisture intrusion/deterioration. Representative areas are pictured. Refer to pest report for further details and locations. We recommend full evaluation by a licensed and qualified Branch 3 certified pest control operator prior to end of contingency period.

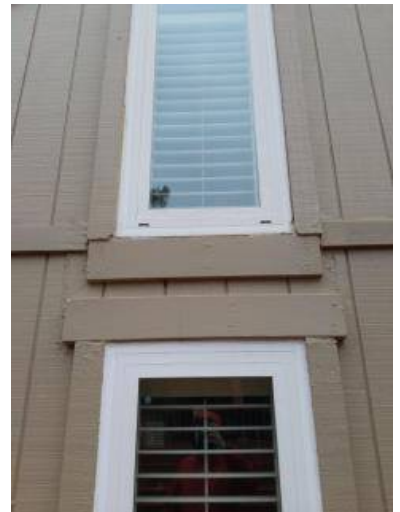
[CR] Prior siding repairs observed. Repairs were not performed in a workmanlike manner. Unsealed joints observed without flashing/z-bar. These conditions are conducive to moisture intrusion/deterioration.

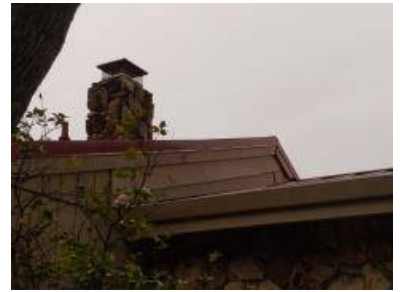
[FE] Fiber cement siding is not installed in a workmanlike manner at pictured area where roof meets siding.

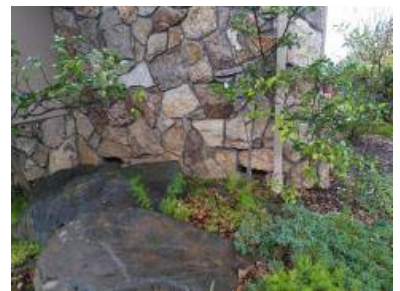
The veneer appeared functional, with exceptions. Note: The veneer is installed below grade level. This configuration may allow pest and moisture intrusion behind veneer.

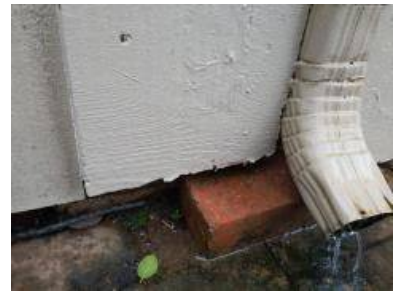
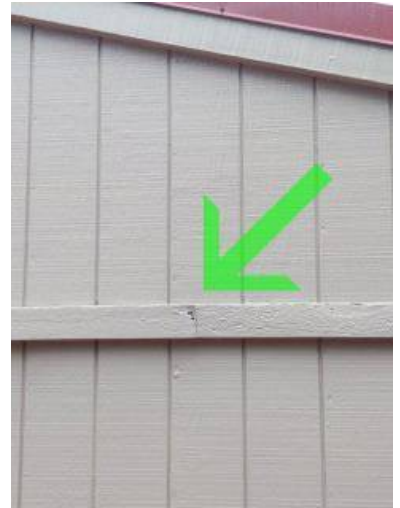
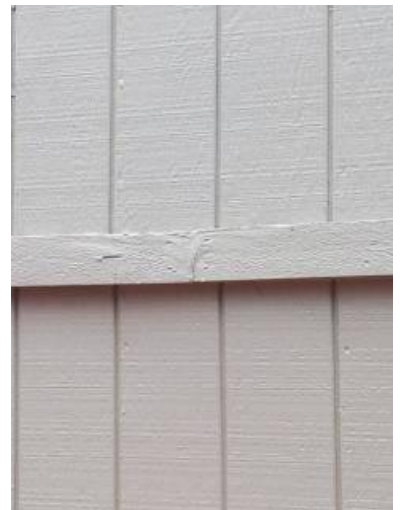
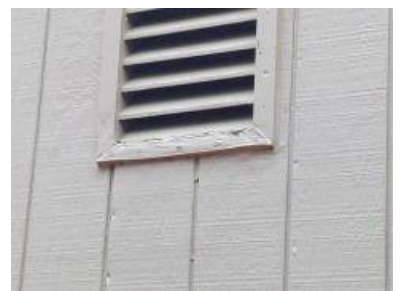
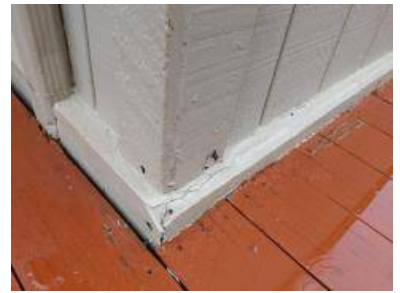
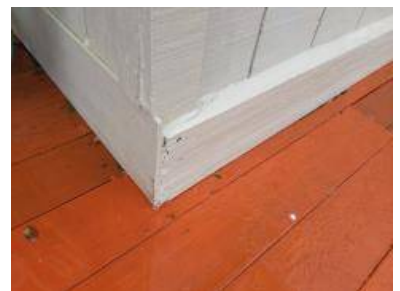
[FE] The wood trim has moisture damage/deterioration at numerous areas of the building. These conditions are conducive to moisture intrusion/deterioration. Representative areas are pictured. Refer to pest report for further details and locations. We recommend full evaluation by a licensed and qualified Branch 3 certified pest control operator prior to end of contingency period.

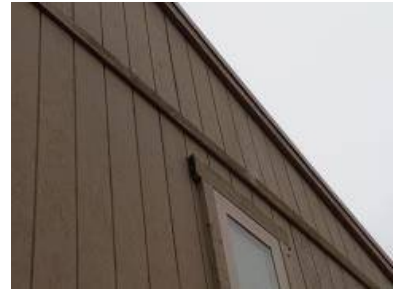
[CR] There are gaps between the trim materials and adjacent materials. Recommend caulking/sealing as necessary.

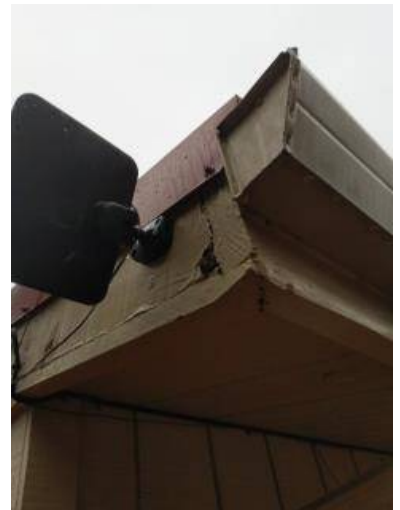
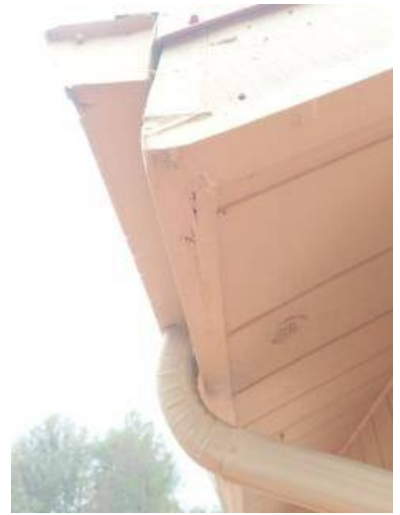
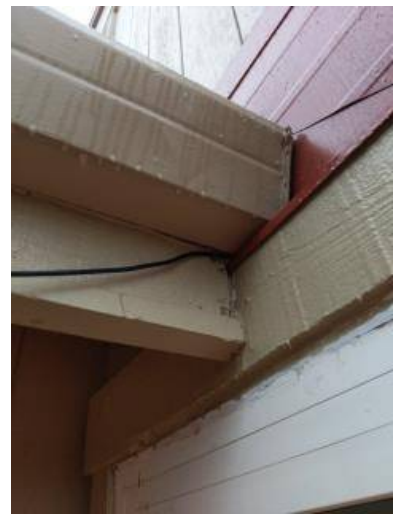
The observed fascia materials appeared functional, with exceptions. [FE] Damaged wood present at localized area of the fascia board. Representative areas are pictured. Refer to pest report for further details and locations. We recommend full evaluation by a licensed and qualified Branch 3 certified pest control operator prior to end of contingency period.

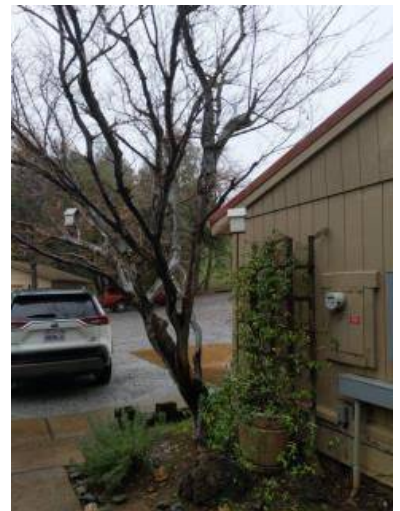
[CR] Tree(s) are planted too close to the building. We recommend considering removal, as trees continue to grow in size and damage may occur to the foundation, structure or roof.

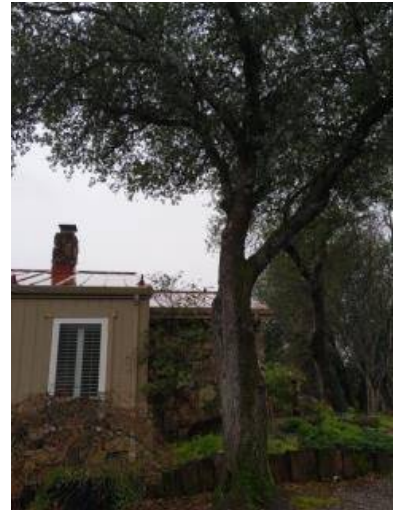
[FE] Large tree is overhanging the home. We are unable to determine whether trees present an imminent hazard. We recommend full evaluation by a licensed and qualified arborist prior to close of escrow.

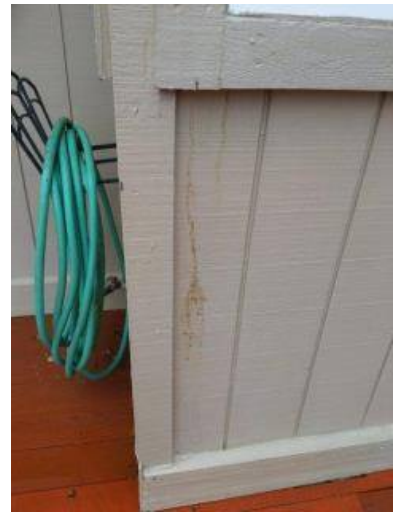
[FE] Storm water was observed running out from behind trim/siding. Concealed damage may exist in this area. We recommend a full evaluation and/or correction(s) by an appropriate professional in the appropriate trade.

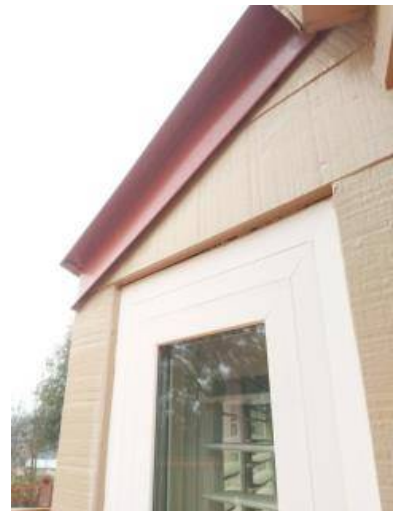
Note: Retrofit widows have been installed. Windows of this type rely on exterior caulking to keep moisture out. The caulking around the windows needs to be checked and maintained on a regular basis to keep the window frames water tight. We recommend checking and maintaining these seals on an ongoing basis to prevent moisture intrusion into concealed spaces. [FE] Retrofit windows have gaps where window frames meet exterior siding.

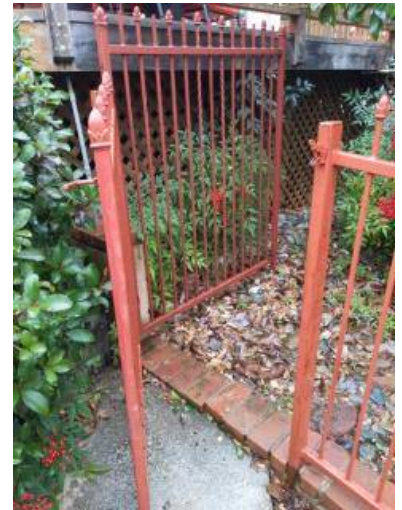
[SC] The gates/fencing did not meet the present pool safety standards. We recommend they be upgraded to the present standards, a copy of which may be obtained at the local building department.

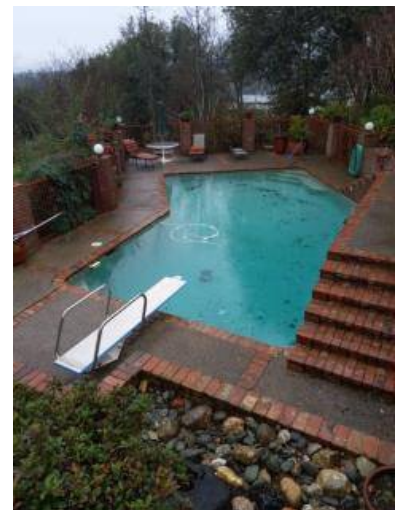
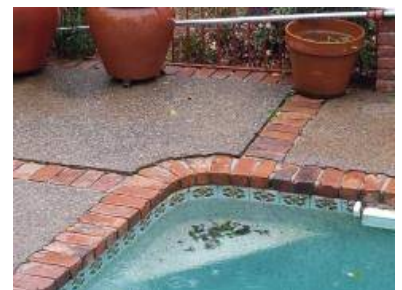
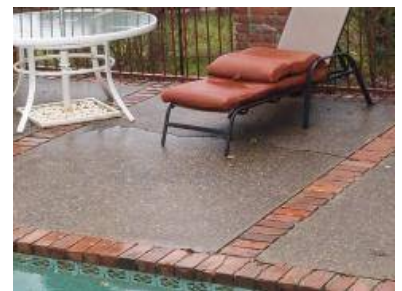
[FE] Evidence of cracking/settling observed around pool deck.

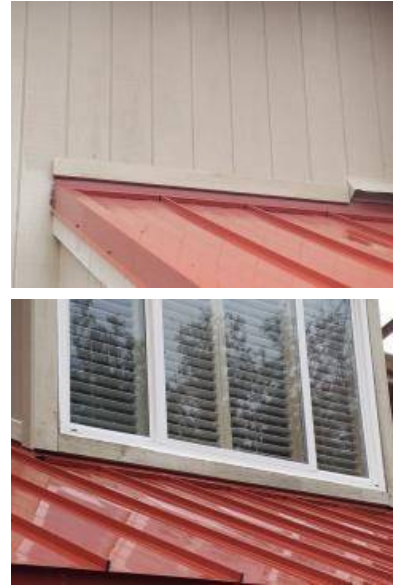
[FE] There are improperly constructed/unsecured flashings at roof to wall junction.

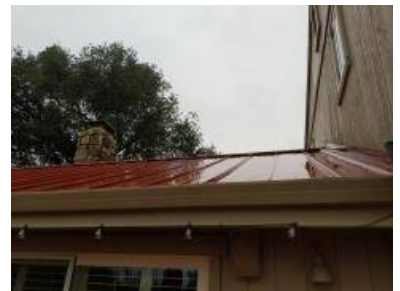
| 406 | ROOF FRAMING | [FE] Sagging roof deck observed in numerous areas. There appears to be sagging of the rafters and/or ceiling joists due to their being over-spanned by today's standards. We are unable to view attic/roof framing due to configuration of building and method of construction. |

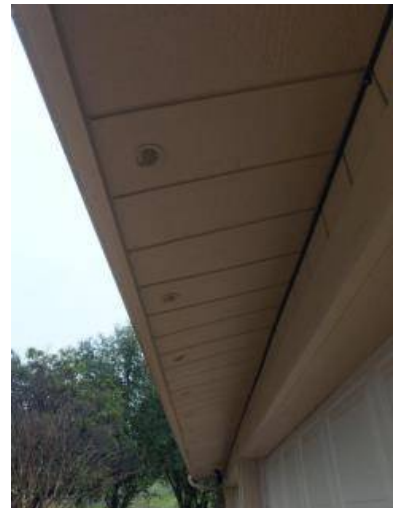
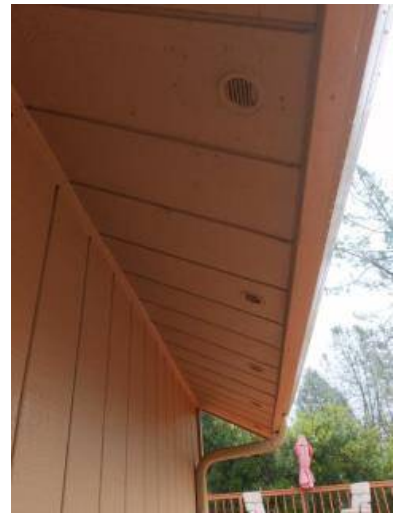
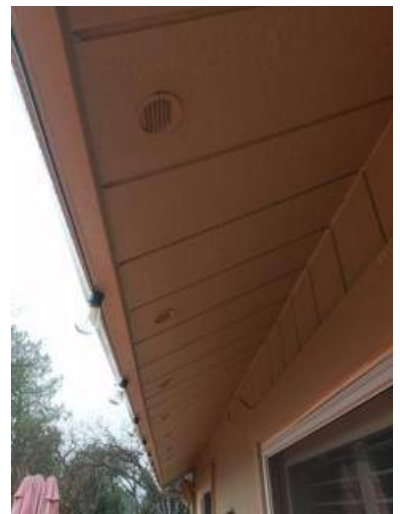
| 416 | VENTILATION | [FE] The attic ventilation is provided by screened holes in eave blocks. This configuration limits attic ventilation. This condition is conducive to moisture build-up in the winter and excess heat build-up in the summer. Recommend replacement of eave blocks with mesh screens as necessary. |

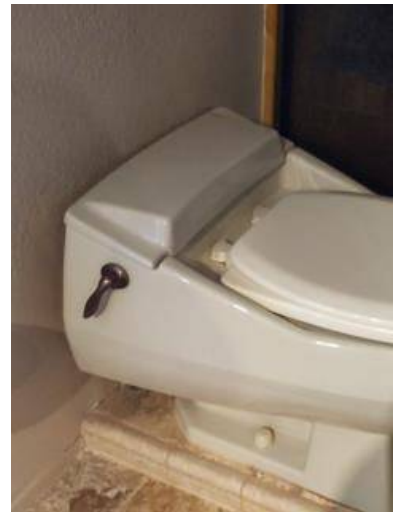
[CR] The toilet refilled slowly.

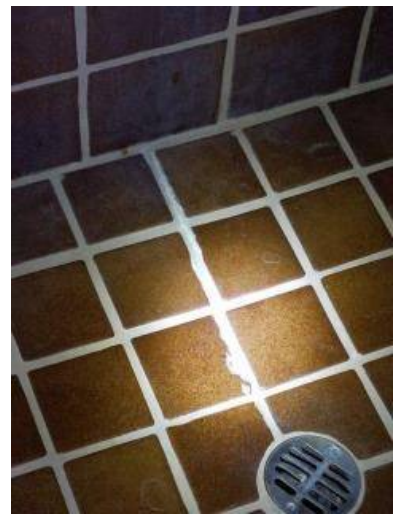
The tub/shower appeared functional, with exceptions. [CR] The grout/caulking is cracked or missing. We recommend correcting this condition to prevent moisture intrusion into concealed spaces.

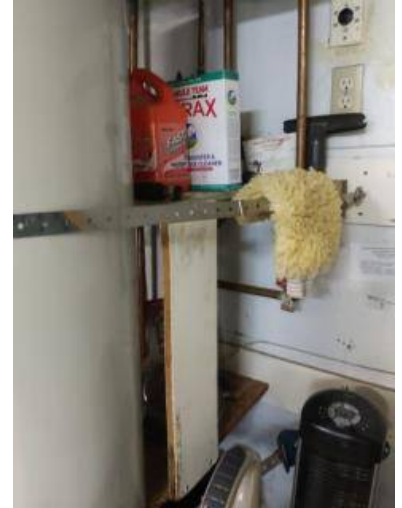
- 534 SUPPLY PIPING** [CR] The shutoff valve and observed water supply connectors are not insulated. We recommend insulating the exposed water piping to minimize heat loss.
- 535 "T & P" VALVE(S)** A temperature & pressure relief valve and discharge line are installed. The discharge line extended and terminated close to the ground facing downward.
- 536 TANK(S)** The water heater tank appeared functional.
- 537 SEISMIC BRACING** [SC] The water heater seismic straps are not installed properly.

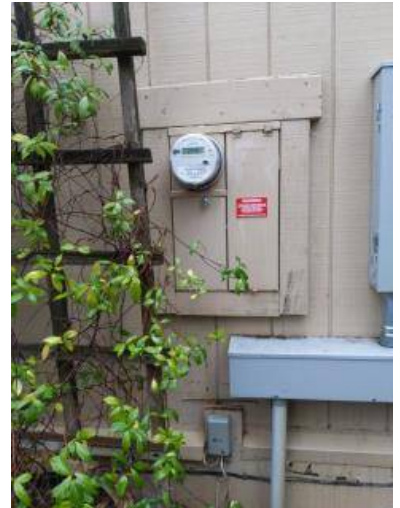
**613 MAIN PANEL** The main panel appeared functional. [CR] Access to the main panel is restricted by vegetation. We recommend the vegetation be trimmed/eliminated to provide safe access to the panel for maintenance or emergency needs.

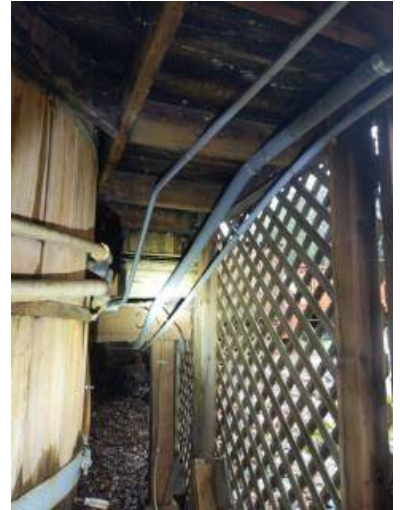
[SC] Conduit is not properly fastened to building.

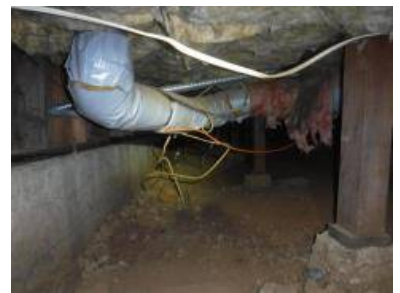
[CR] Numerous areas of wiring in the crawlspace are unsecured/hanging/loose.

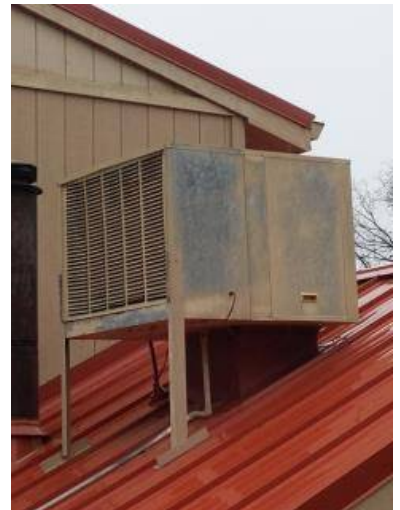
[CR] The evaporative cooler pads are deteriorated. Recommend replacement.

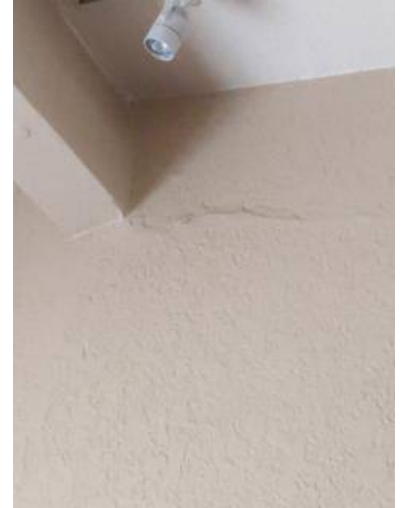
- 907 WALL(S)/CEILING(S)** The observed areas of the walls and ceiling appeared functional with exceptions.  
[FE] Moderate drywall cracks observed. This may be due to wood support framing shrinkage, building settlement/movement, and/or possible past seismic events.

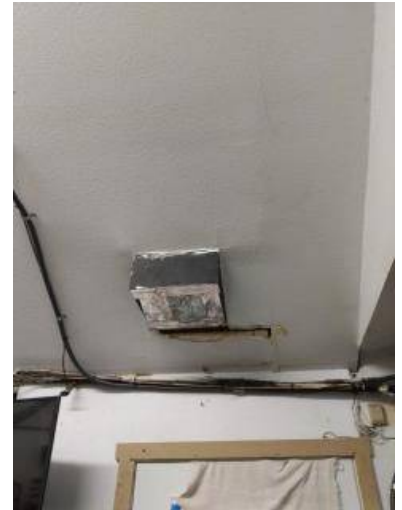
[FE] Moisture stains and damage observed on the ceiling(s). There are indications of what appeared to be an unknown black substance. Substance may be organic in nature. We recommend further testing to determine whether mold is present. We recommend locating and correcting the source and any damaged materials.

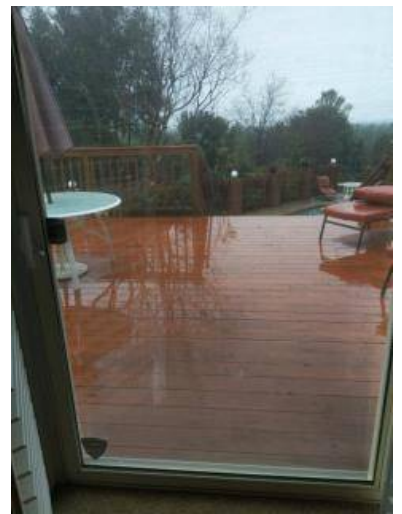
[FE] Condensation/stains observed between the glass panes in the thermal door(s). We recommend having all of the doors and windows evaluated by an appropriate professional in the appropriate trade.

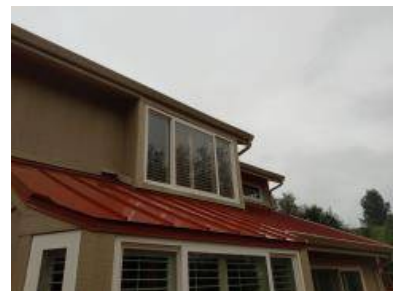
[CR] There are missing window screens.

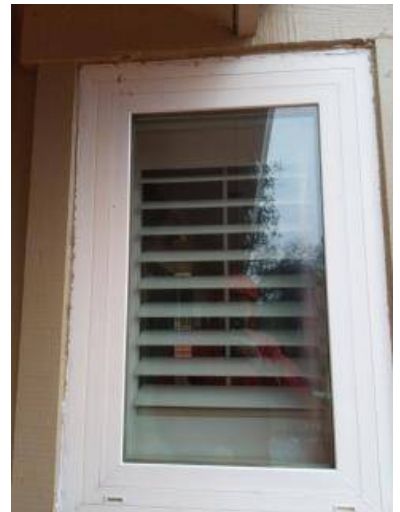
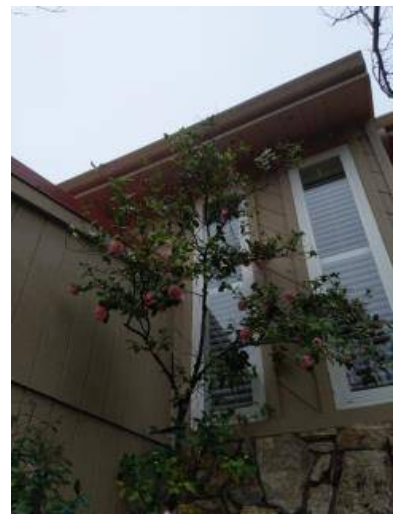
[FE] Condensation/stains observed between the glass panes in the thermal window(s). We recommend having all of the doors and windows evaluated by an appropriate professional in the appropriate trade.

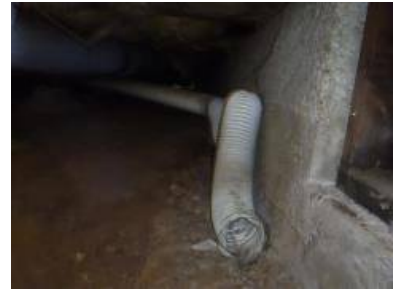
[SC] The dryer vented under the building. This is an inappropriate termination point and can pose a safety hazard.
