# Home Inspection Report

**13579 Phaedra Lane, Redding CA**

**Riley Johnson, CCI**

**Shasta Home Inspections, LLC**  
**530-945-6292 [Shastainspections@gmail.com](mailto:Shastainspections@gmail.com)**

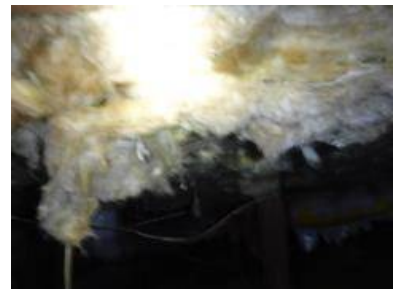
**INSULATION****120 INSULATION**

The floor framing insulation appeared functional, with exceptions. [CR] Subfloor insulation is damaged in several areas. Missing areas of insulation reduces the overall performance of the subfloor insulation.

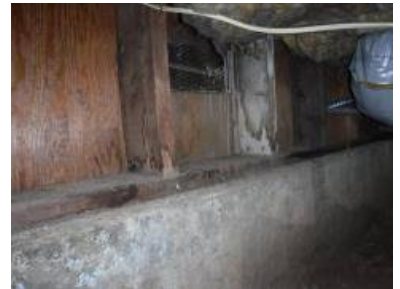
[FE] Evidence of prior or current rodent activity noted in crawlspace. Recommend evaluation and/or treatment by a licensed pest control specialist.

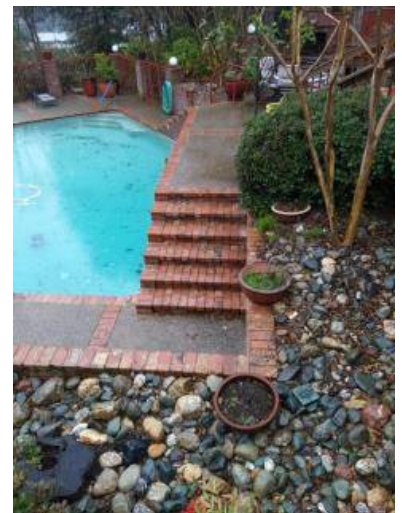
**222 HANDRAIL(S)**

[SC] There are no handrail(s) where required at the pictured area.

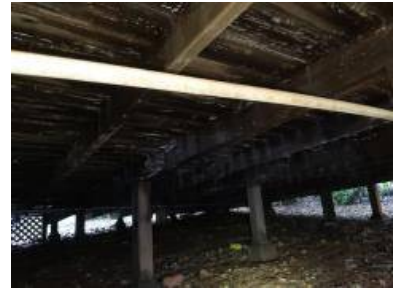
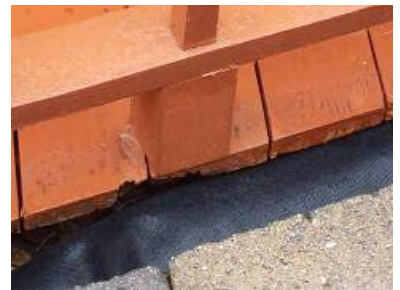
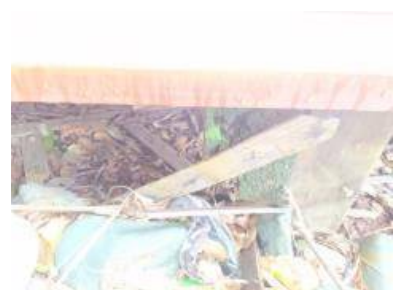
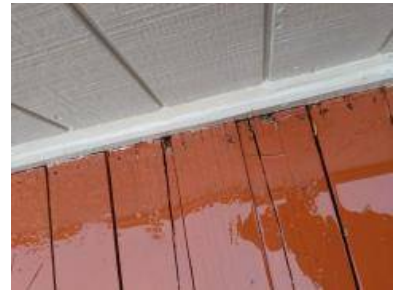
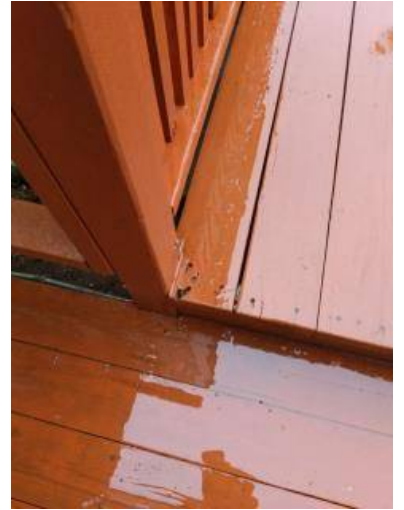
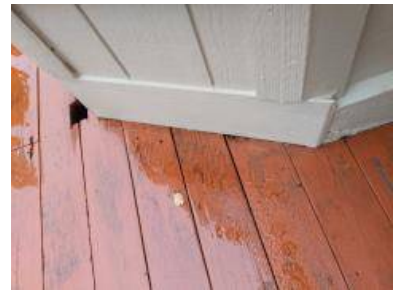
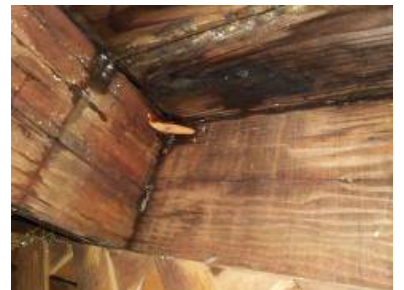
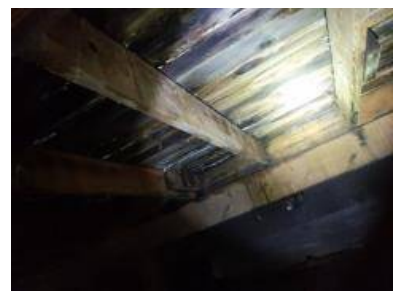
## 229 DECK(S)

[FE] Numerous areas of damage observed at all deck platforms and framing. Surface fungus and moisture related damage observed throughout deck. All decking will require major repairs or replacement.

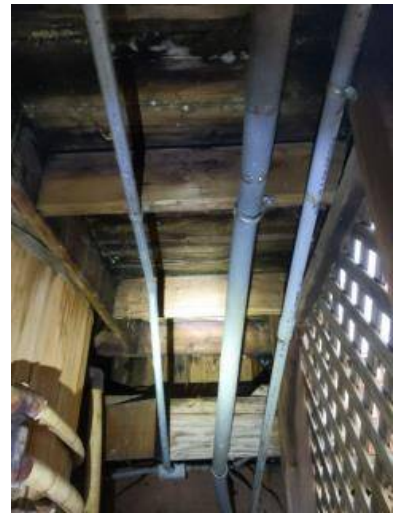
[CR] The deck lacks proper flashing where it meets the siding. Water may pond in this area and damage deck and siding.

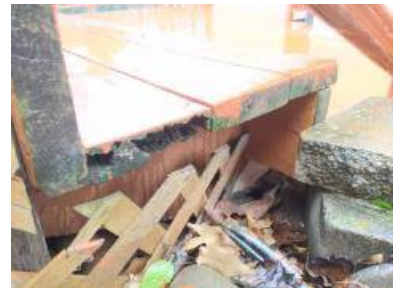
[CR] The deck stairs are in contact with soil.

[CR] Moisture-related damage observed on the steps/stairs.

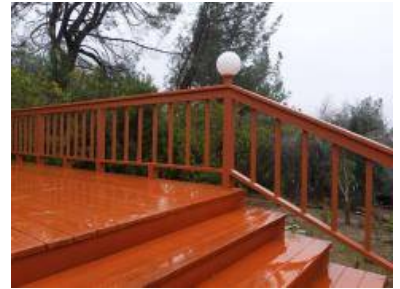
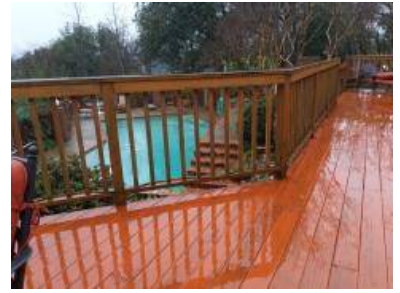
[SC] The guardrail balusters have spaces/gaps. Maximum allowable space between balusters is 4". This is a safety concern for small children and pets.

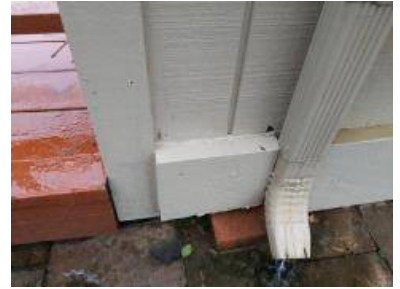
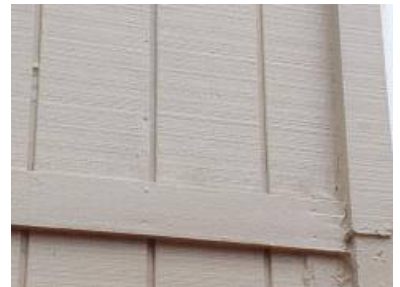
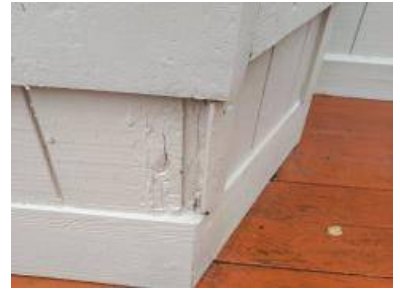
### 239 WOOD SIDING

[FE] The wood siding has moisture damage/deterioration at localized areas of the building. These conditions are conducive to moisture intrusion/deterioration. Representative areas are pictured. Refer to pest report for further details and locations. We recommend full evaluation by a licensed and qualified Branch 3 certified pest control operator prior to end of contingency period.

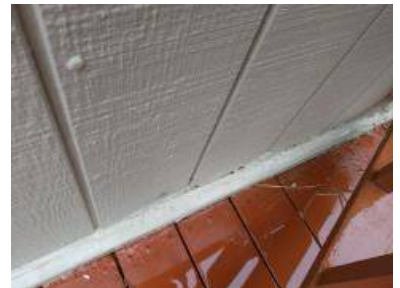
[CR] The wood siding finish appeared weathered in several areas. Paint is peeling.

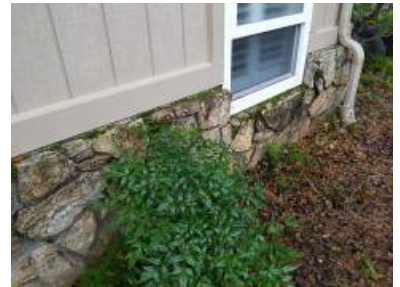
**246 VENEER**

The veneer appeared functional, with exceptions. Note: The veneer is installed below grade level. This configuration may allow pest and moisture intrusion behind veneer.

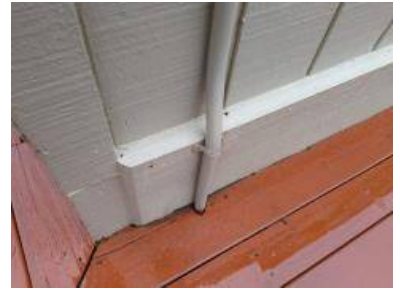
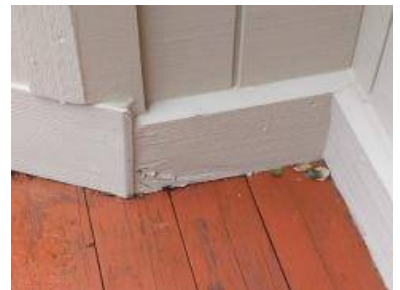
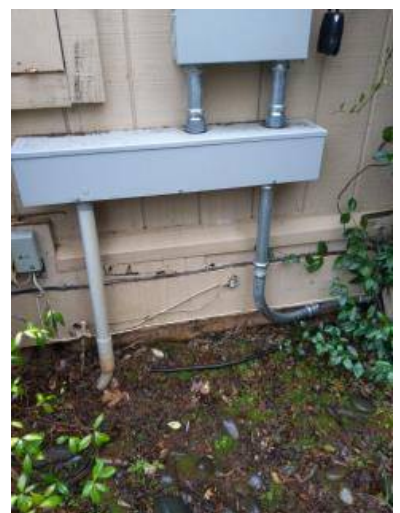
## 248 EXTERIOR TRIM

[FE] The wood trim has moisture damage/deterioration at numerous areas of the building. These conditions are conducive to moisture intrusion/deterioration. Representative areas are pictured. Refer to pest report for further details and locations. We recommend full evaluation by a licensed and qualified Branch 3 certified pest control operator prior to end of contingency period.

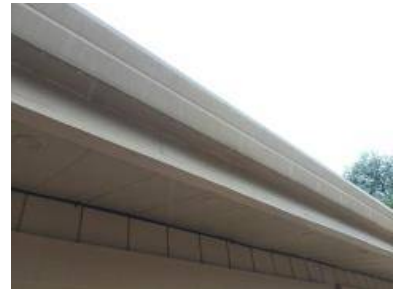
**250 FASCIA(S)**

The observed fascia materials appeared functional, with exceptions. [FE] Damaged wood present at localized area of the fascia board. Representative areas are pictured. Refer to pest report for further details and locations. We recommend full evaluation by a licensed and qualified Branch 3 certified pest control operator prior to end of contingency period.

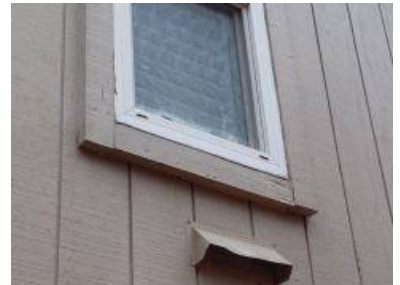
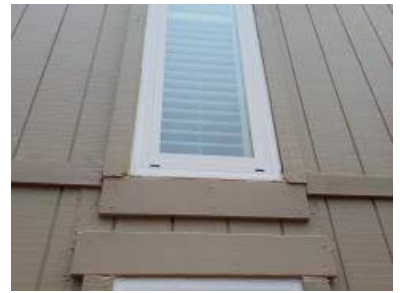
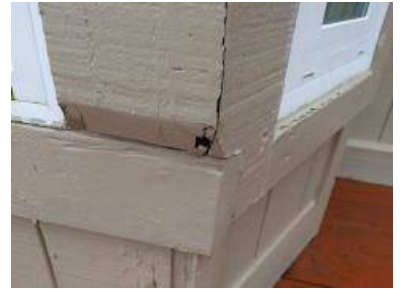
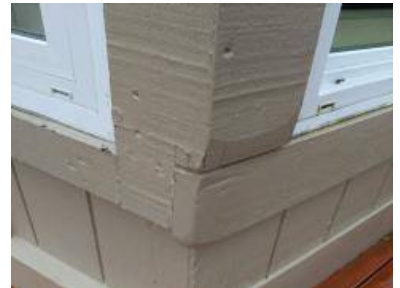
[FE] Damaged wood observed at window frames/sills. Gaps observed between several window frames and trim/siding in areas. This condition is conducive to moisture intrusion and deterioration. Concealed damage may exist. Recommend sealing/repairs as necessary.

Note: Retrofit widows have been installed. Windows of this type rely on exterior caulking to keep moisture out. The caulking around the windows needs to be checked and maintained on a regular basis to keep the window frames water tight. We recommend checking and maintaining these seals on an ongoing basis to prevent moisture intrusion into concealed spaces. [FE] Retrofit windows have gaps where window frames meet exterior siding.

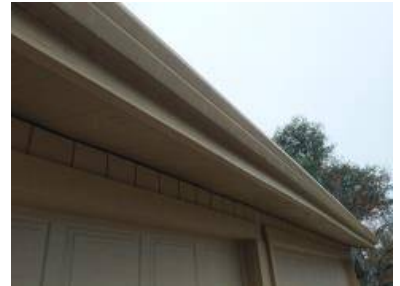
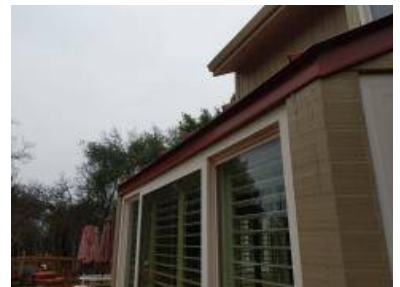
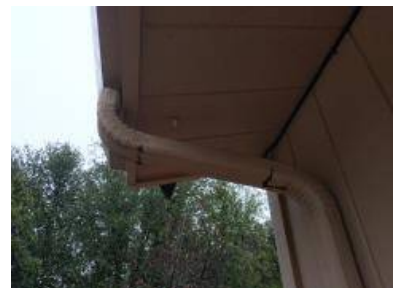
[CR] The downspout(s) are leaking at joints.

[CR] Downspout(s) are not properly secured to building.

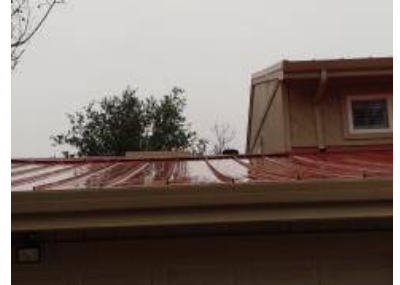
| 406 | ROOF FRAMING | [FE] Sagging roof deck observed in numerous areas. There appears to be sagging of the rafters and/or ceiling joists due to their being over-spanned by today's standards. We are unable to view attic/roof framing due to configuration of building and method of construction. |

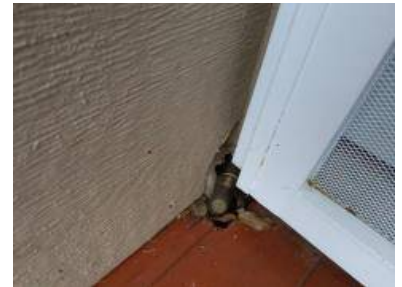
| <b>507 WATER PIPING</b> | <p>The observed water supply piping appeared functional. Water pressure at an exterior hose faucet tested at 65 psi.</p> <p>[CR] Pictured water supply pipe installed outside wall cavity.</p> |

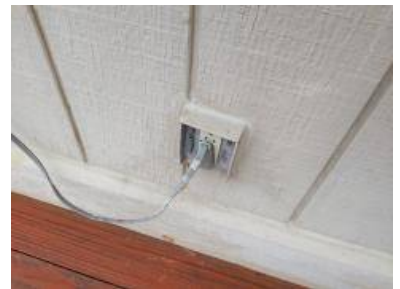
[CR] Exterior weather proof receptacle cover plates are missing.

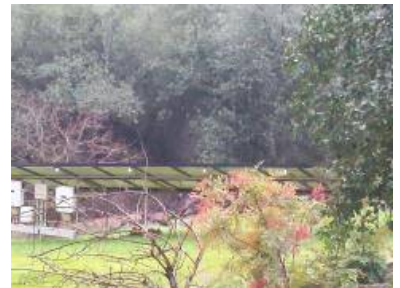
### 634 SOLAR PANELS AND RELATED EQUIPMENT

[FE] These system(s) are outside the scope of the inspection and are not inspected. We recommend consulting with an appropriate professional in the appropriate trade regarding the operation and maintenance of this system. Any comments made are as a courtesy only.

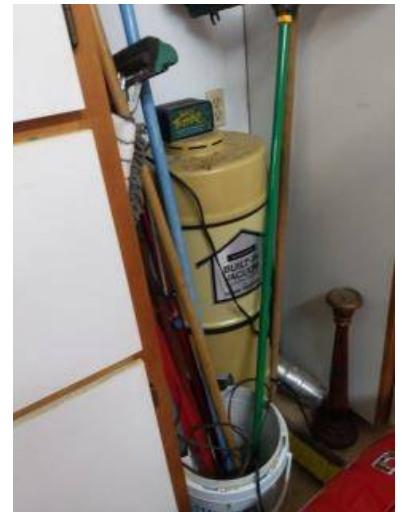
**635 CENTRAL VACUUM**

[FE] These system(s) are outside the scope of the inspection and are not inspected. We recommend consulting with an appropriate professional in the appropriate trade regarding the operation and maintenance of this system. Any comments made are as a courtesy only.

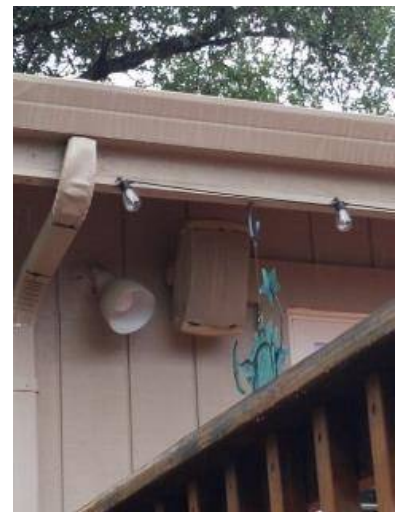
**636 AUDIO/VIDEO**

[FE] These system(s) are outside the scope of the inspection and are not inspected. We recommend consulting with an appropriate professional in the appropriate trade regarding the operation and maintenance of this system. Any comments made are as a courtesy only.

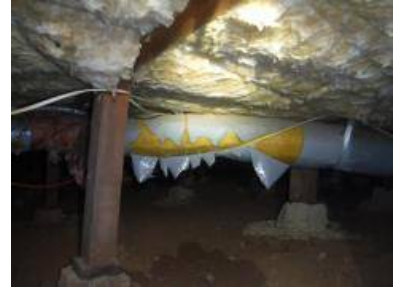
### 733 DUCT CONDITIONS

The observed areas of the conditioned air ducts appeared functional with exceptions.  
[CR] The outer plastic covering on the conditioned air ducts is deteriorated.

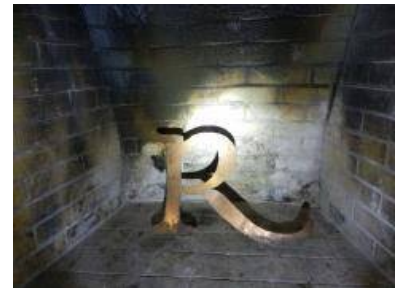
| 807 FIREBOX(S) | [FE] Cracking and spalling observed at masonry firebox. Recommend full evaluation of chimney and firebox by an appropriate tradesperson. |

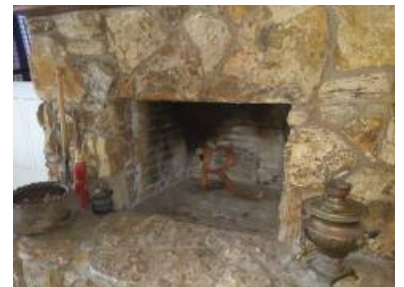
[SC] No fireplace doors installed.

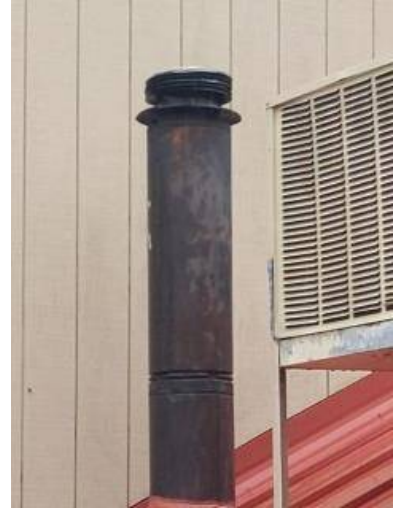
### 805 CHIMNEY(S)

Note: pictured chimney is not in use. Chimney lacks sufficient height/clearance.

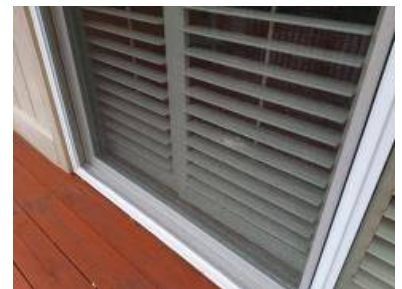
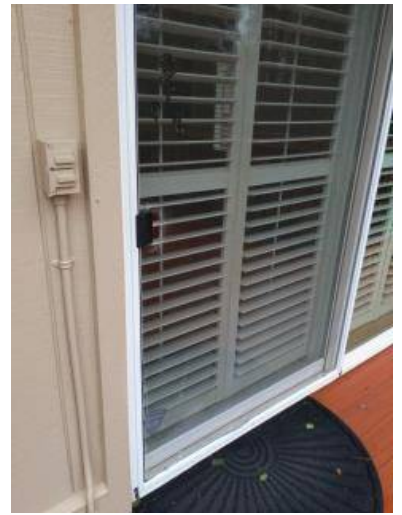
- 915 INTERIOR DOOR(S)** The doors are functional.
- 916 EXTERIOR DOOR(S)** The door(s) are functional with exceptions.  
[CR] The screen door(s) have damaged mesh.

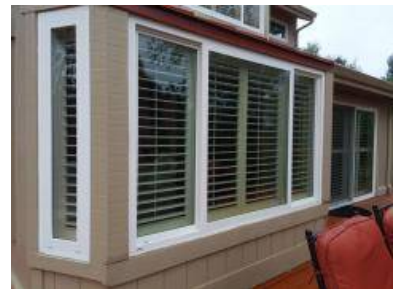
[CR] There are missing window screens.

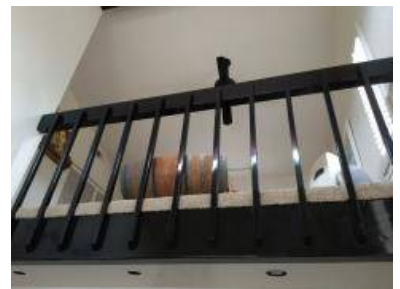
- 923 STAIRWELL(S) The stairs are functional.
- 924 HANDRAIL(S) The handrail(s) are functional.
- 925 GUARDRAIL(S) [SC] The guardrails installed have wide spaces. Spacing between balusters should not exceed 4". We recommend additional measures be taken for child safety.

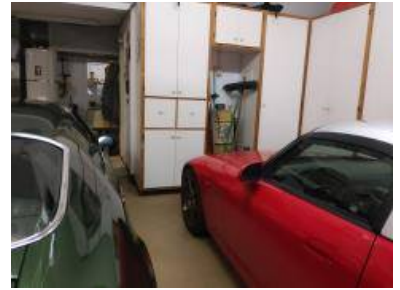
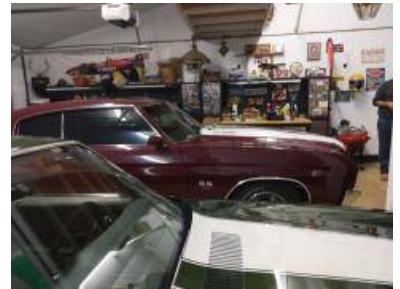
## 971 GARAGE FLOOR(S)

The observed areas of the garage floor appeared functional with exceptions.  
[FE] The floor is not fully observable, due to stored items. We recommend checking these areas after the stored items are removed.
